The Landis Theatre / Mori Brothers Building complex is located on the southwest corner of Landis and East Avenues. City of Vineland Tax Maps indicate the property as Lot 7 of Block 454. The physical address of the property is listed as 834—836 E. Landis Avenue.

Outer Lobby

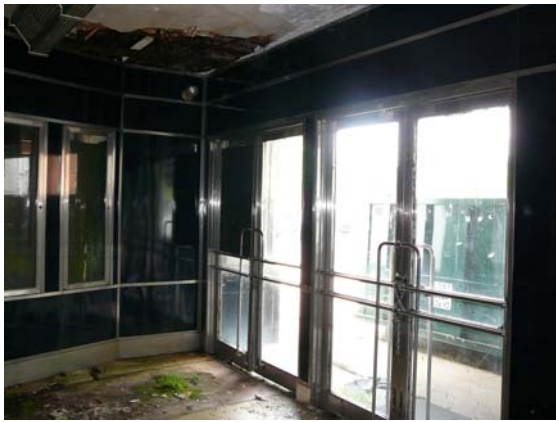
Exterior doors, note fire damaged ceiling and walls

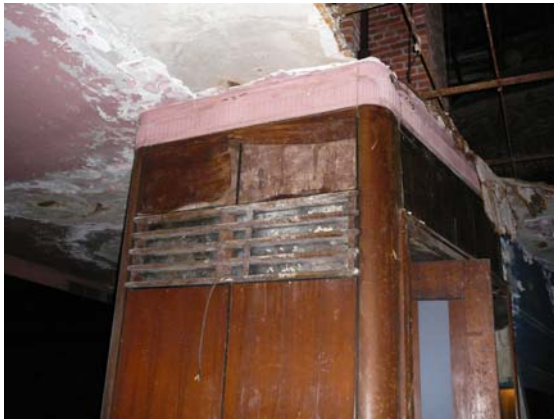
Wood veneered mechanical shaft, note failed plaster ceilings

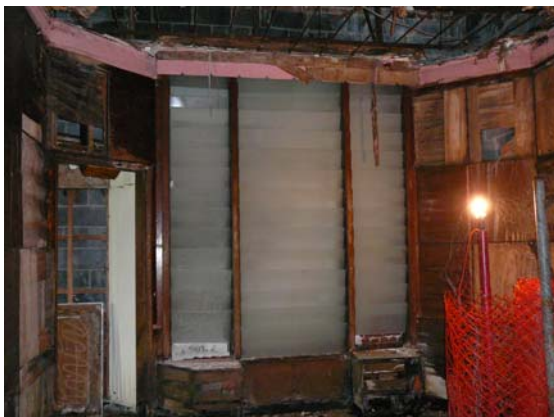
Backlit glass louver with planter box, note missing ceiling

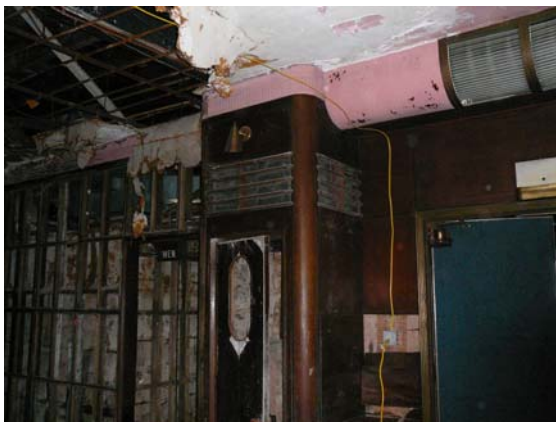
Original telephone booth at east side, note exposed framing

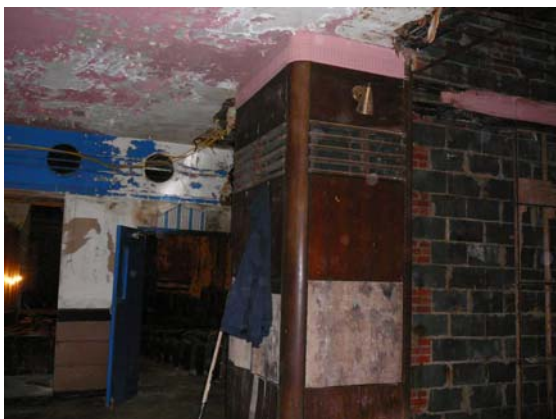
Wood veneered shaft with louver, note bare concrete walls

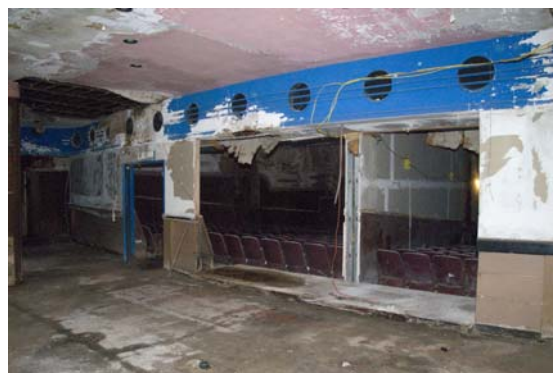
Inner foyer, note porthole soffit, missing ceilings and fifth build wall

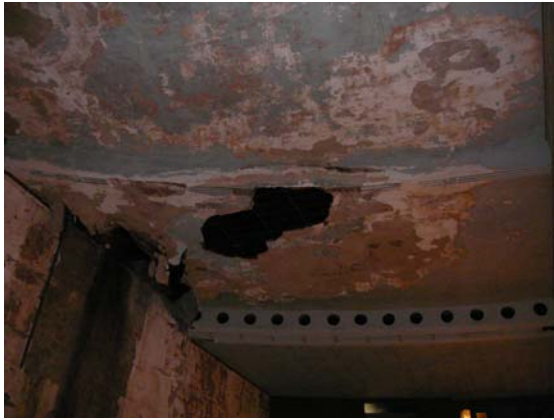
Failed plaster ceiling at east side of auditorium

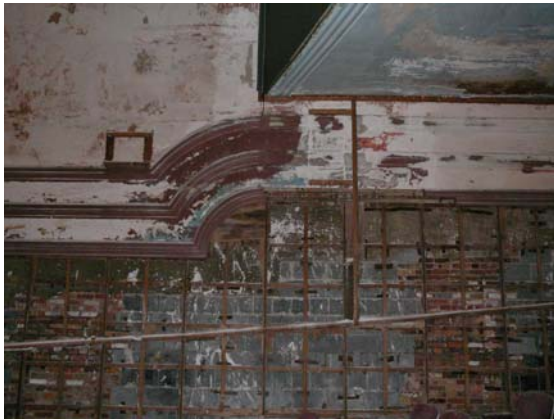
Plaster banding at sidewalls, note missing wood veneer

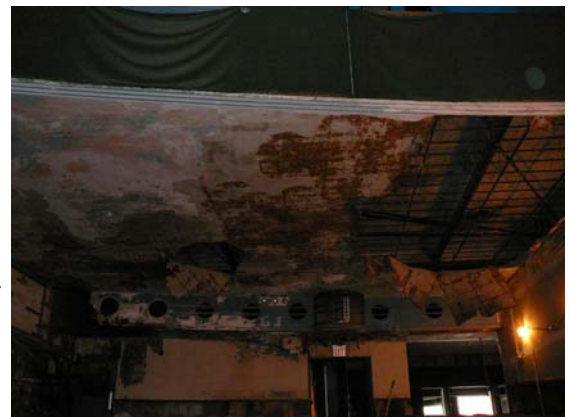
As a whole, the auditorium is in poor to very poor condition. Side wall finishes and trim require total replacement as does approximately 25% of the plaster ceilings. Ceilings below the mezzanine require total replacement. The existing sloped floor does not satisfy today's requirements for sight lines as well as handicap accessibility as there are no landings provided as required. Electrical and mechanical systems require total replacement. Additional electrical components required to operate the theatre have been removed prior to obtaining access to the facility.

Failed plaster ceiling below mezzanine, note porthole diffusers

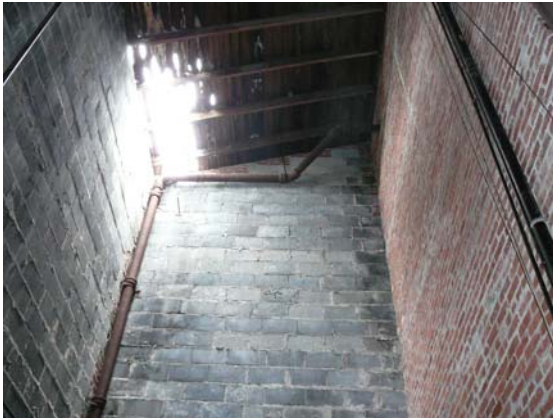
Failed roof system at fly gallery

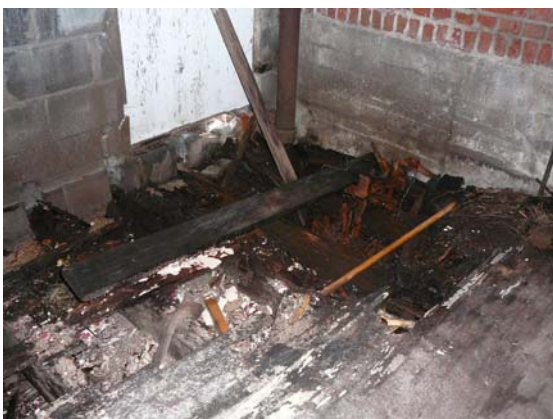
Extensive water damage at stage floor and structure

The main stage area has suffered extensive damage as a result of water penetration through a failed roof system. The wood floors have rotted away at the exterior perimeters of the stage and structural framing stability is suspect, creating a hazardous condition. The footlights are missing as is the original ruby colored fabric curtain. The roofing over the stage is deteriorated and large openings to the exterior have allowed major water penetration and damage to this area. The original suspended stage lights are still in place although all wiring to these fixtures are missing or deteriorated.

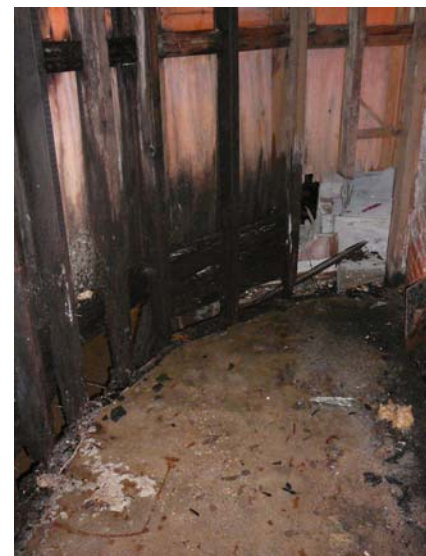
Rotted structure and veneer at small green room at stage east

The storage / green room area is in very poor condition with rotted wood framing, exposed electrical wiring and a moldy bare concrete floor. The concrete steps leading to this area are not code compliant as are the access doors between the auditorium and the backstage.

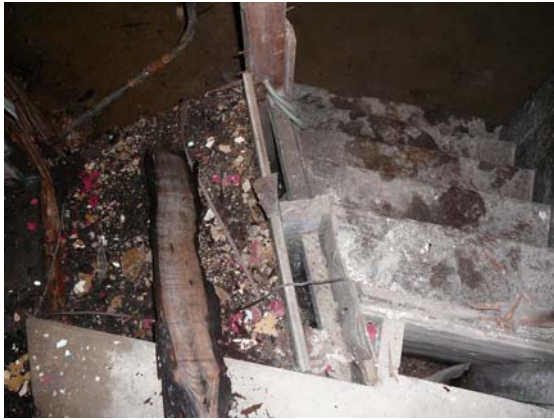
View of rotted platform and steps from stage

The steps leading to the stage directly from the auditorium are structurally unsound as are the platforms flanking them. The orchestra pit has been filled in with light framing. The pit is undersized for today's needs with room for approximately 4 individuals.

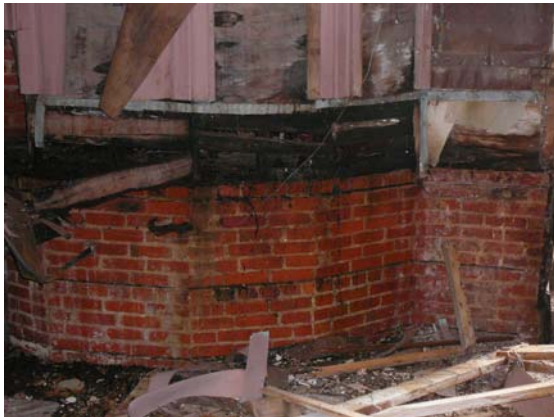
Vertical assembly with missing veneer, original trim remains

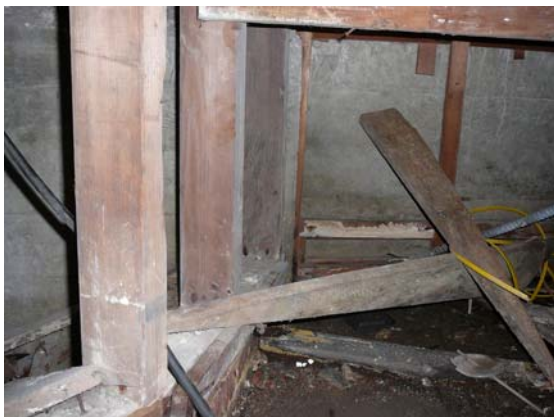
Exposed wood framing at vertical assemblies flanking stage

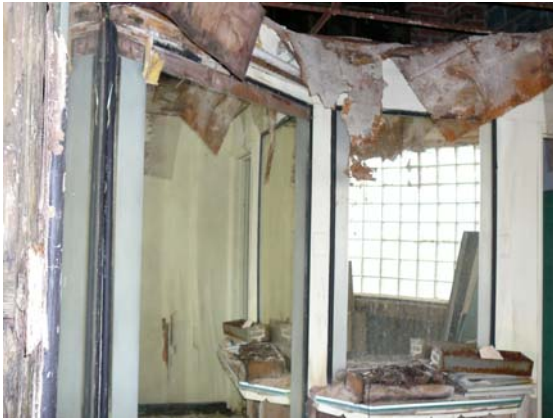
Triple mirrored wall at lounge, note failed plaster ceiling

Existing conditions at both lounges is very poor. Clogged and/or failed internal roof drains within wall cavities have caused multiple roof failures in the immediate area. Additional roof issues will be discussed in the exterior portion. Wood wall framing is rotting due to constant water penetration. The minute amount of remaining paneling is not salvageable. A majority of the pink plaster ceiling is missing and the floor is bare concrete. The laminate counters are missing and the remaining mirrors appear not to be original. There is no evidence of how the space was lit as no fixtures were encountered. No mechanical equipment remains. The curved glass blocks will be discussed in the exterior portion.

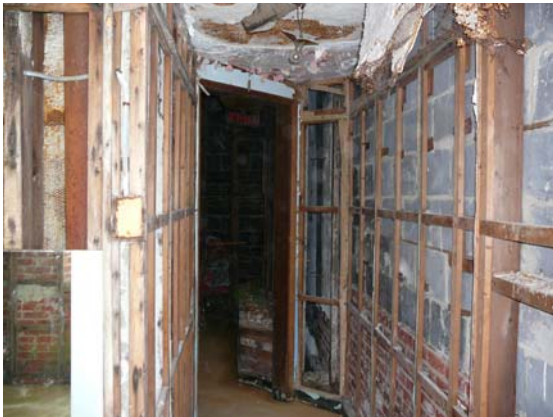
Access hallway to lounge, note missing paneled veneer

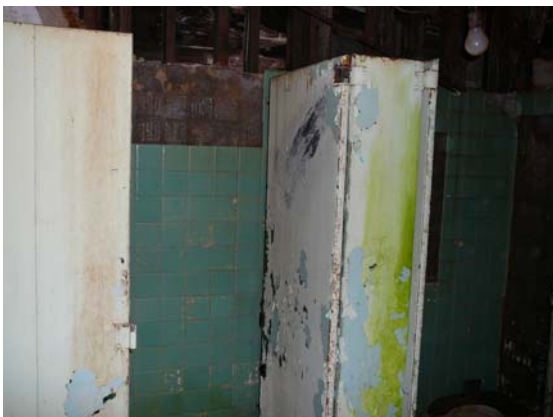
Existing conditions at both restrooms is very poor. Tile wainscot and it’s plaster backing have peeled away from the walls, plaster ceilings are missing, plumbing fixtures are non-functional and the metal toilet partitions that remain are rusting. There is no accessibility for the handicapped with the current fixture arrangement. There are no remaining light fixtures.

Rusted toilet partition and failed plaster wall at restroom

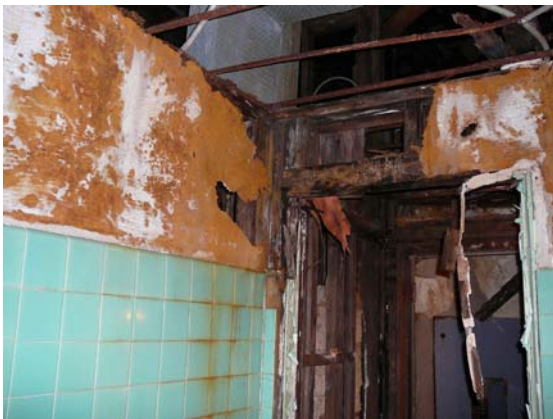
Failed plaster and rotting wood framing at entrance

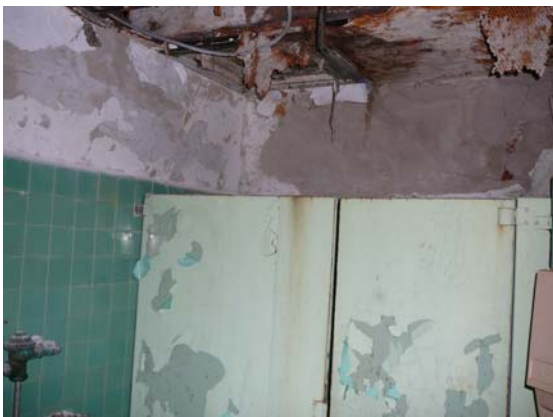
Existing conditions at both restrooms is very poor. Tile wainscot and it's plaster backing have peeled away from the walls, plaster ceilings are missing, plumbing fixtures are non-functional and the metal toilet partitions that remain are rusting. There is no accessibility for the hand-capped with the current fixture arrangement. There are no remaining light fixtures.

Rusted toilet partitions, failed plaster ceiling

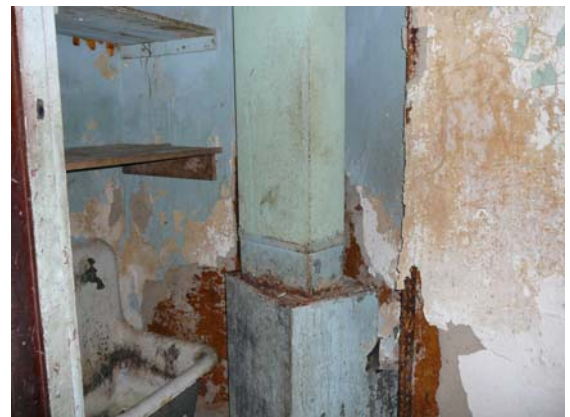
As with most of the secondary spaces below the low roof portion of the structure, the condition of this space is very poor. Plaster walls are failing, there is bare concrete on the floor and the mop sink is non-functional.

Mop sink and mechanical duct at Janitor's closet
