The Landis Theatre / Mori Brothers Building complex is located on the southwest corner of Landis and East Avenues. City of Vineland Tax Maps indicate the property as Lot 7 of Block 454. The physical address of the property is listed as 834—836 E. Landis Avenue.

Outer Lobby

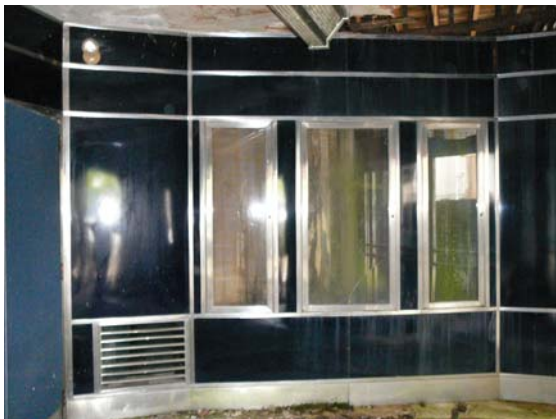
Angled side wall with display cases, note metal air register

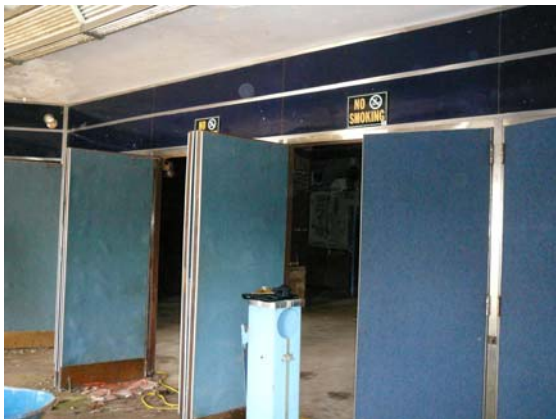
Interior doors to foyer, note colored metal panels

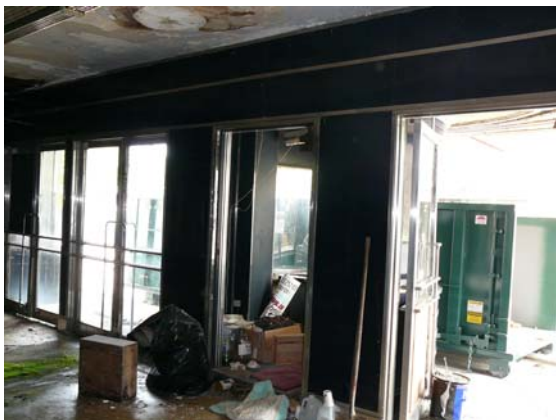
Exterior metal and glass doors and door to ticket booth

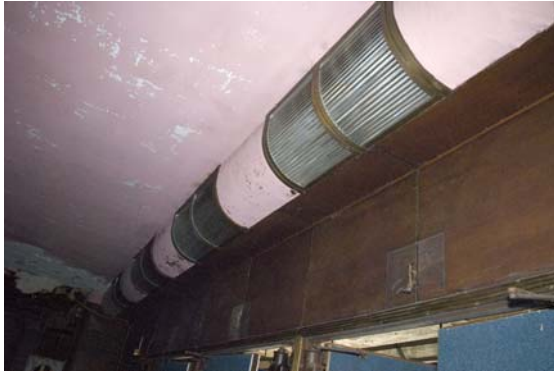
Glass rod light fixtures at soffit above lobby doors

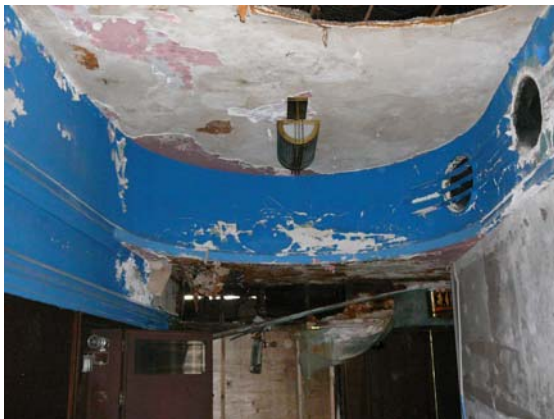
Light fixture at inner foyer, note curved plaster soffit with trim

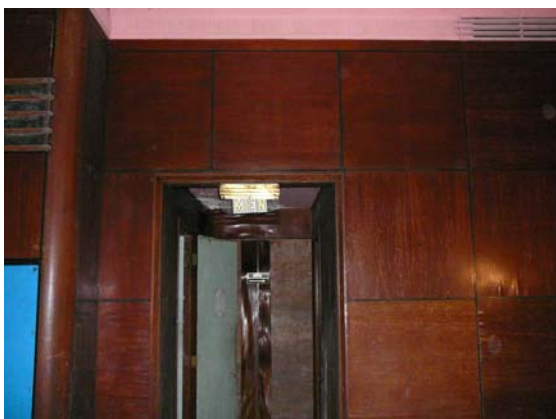
West side hallway to men's room and janitor's closet

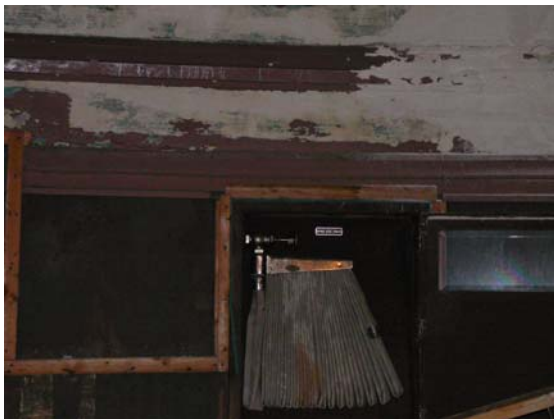
Original fire hose cabinet at front of auditorium

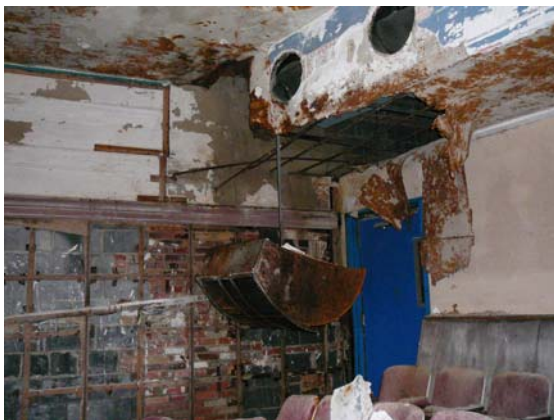
Mechanical soffit at rear of auditorium with hanging light fix-

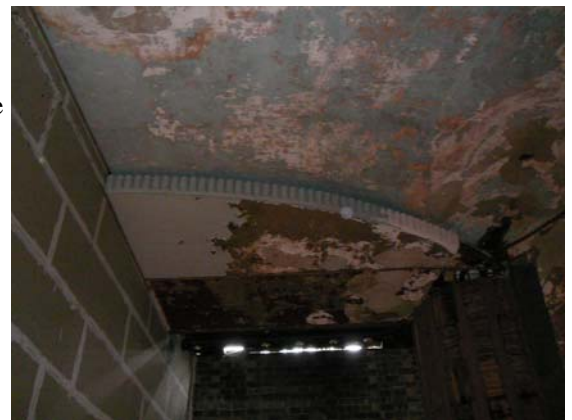
Arched soffit with sound blocks at edge of proscenium

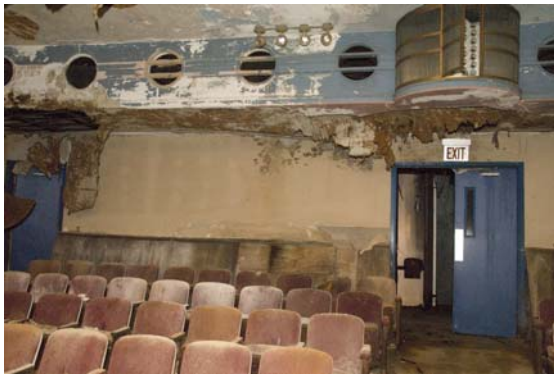
One of four glass bar light fixtures at rear of auditorium

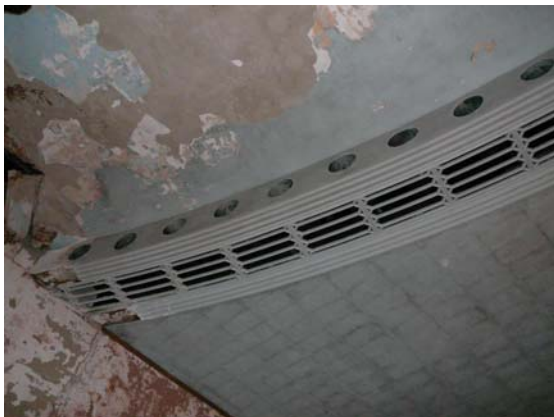
Mechanical diffusers and portholes at 2nd soffit step

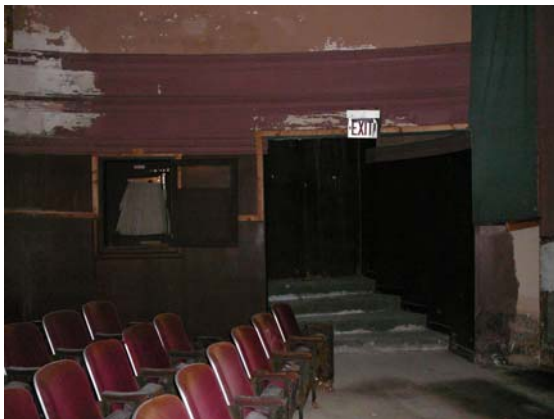
Exit alcove at west side of auditorium adjacent to stage

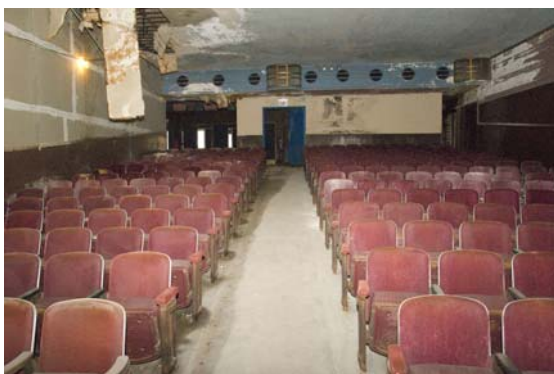
West auditorium with fifth build demising wall at left

The main auditorium of the theatre has sustained severe damage as a result of water penetration through the failed roof system at internal gutters on either end of the space. The three rows of stepped plaster banding are badly damaged in various areas. A wall dividing the space was constructed in the 1970's without concern of preserving the original construction. Additionally, a concession stand was carved out of the central rear portion of the auditorium, removing a large portion of the original rear wall. Seating arrangements were modified with only 800 total seat spaces provided. Floors are exposed concrete, exterior walls are void of wood paneling and failing plaster above. The ceilings are severely damaged at the side walls, as are the soffits and additional plaster trim. All ornamental elements have been painted over showing no evidence of the original bronze coloring. The banks of rainbow lights in the mezzanine are covered over, exposed areas show missing glass panels. The four glass rod soffit lights are intact for the most part, although one is hanging in mid-air from the flexible metal conduit attached to it's rear. There is no evidence that the vertical assemblies at either side of the stage housed additional rainbow lighting elements. Plaster ceilings below the mezzanine are failing as water has worked it's way through the upper concrete floors. Evidence of at least two small fires in the auditorium have further damaged the interior finishes as well as multiple seats. As constructed, the east side auditorium violates code in terms of egress.

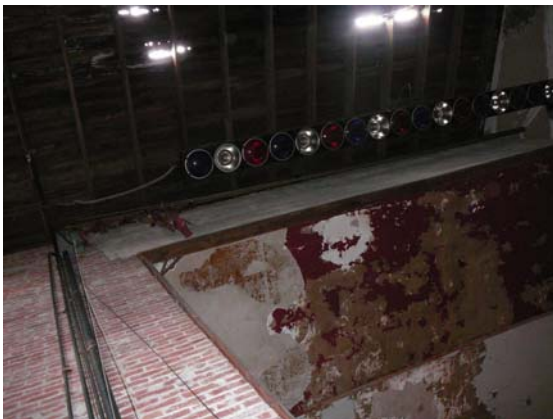
Remaining light fixtures over proscenium

The main stage area has suffered extensive damage as a result of water penetration through a failed roof system. The wood floors have rotted away at the exterior perimeters of the stage and structural framing stability is suspect, creating a hazardous condition. The footlights are missing as is the original ruby colored fabric curtain. The roofing over the stage is deteriorated and large openings to the exterior have allowed major water penetration and damage to this area. The original suspended stage lights are still in place although all wiring to these fixtures are missing or deteriorated.

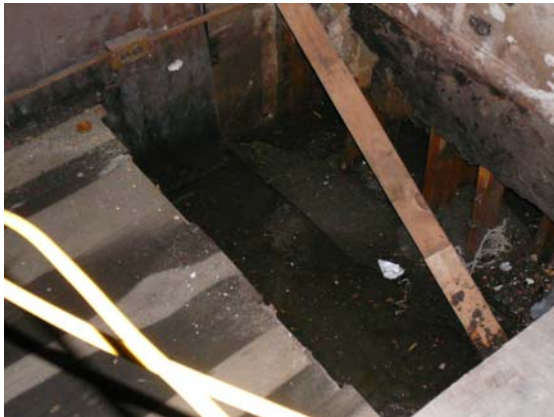
View of steps and exposed brick at vertical assembly

The steps leading to the stage directly from the auditorium are structurally unsound as are the platforms flanking them. The orchestra pit has been filled in with light framing. The pit is undersized for today's needs with room for approximately 4 individuals.

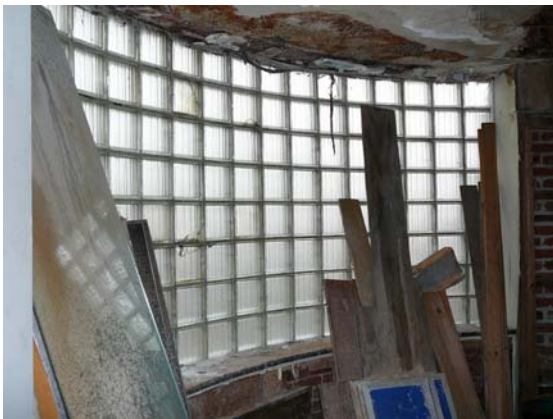
Curved glass block wall at lounge

Existing conditions at both lounges is very poor. Clogged and/or failed internal roof drains within wall cavities have caused multiple roof failures in the immediate area. Additional roof issues will be discussed in the exterior portion. Wood wall framing is rotting due to constant water penetration. The minute amount of remaining paneling is not salvageable. A majority of the pink plaster ceiling is missing and the floor is bare concrete. The laminate counters are missing and the remaining mirrors appear not to be original. There is no evidence of how the space was lit as no fixtures were encountered. No mechanical equipment remains. The curved glass blocks will be discussed in the exterior portion.

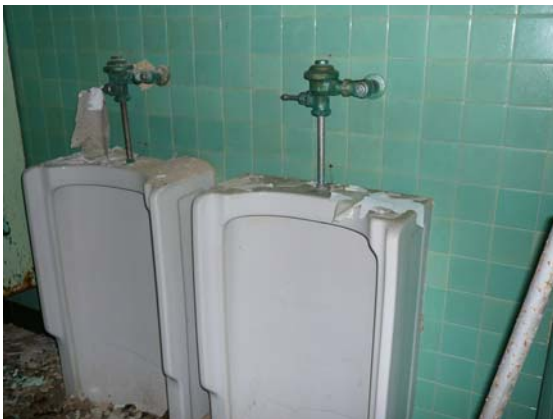
Floor mounted urinals

Existing conditions at both restrooms is very poor. Tile wainscot and it's plaster backing have peeled away from the walls, plaster ceilings are missing, plumbing fixtures are non-functional and the metal toilet partitions that remain are rusting. There is no accessibility for the hand-capped with the current fixture arrangement. There are no remaining light fixtures.

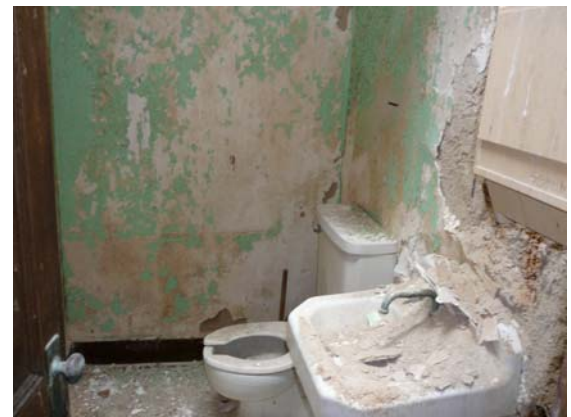
5. Employee toilet room

Employee toilet room (image 5): the employee restroom consist of a wall hung sink and a floor mounted tanked toilet. There is a skylight which straddles the wall between the toilet room and the employee lounge which provides natural lighting into these areas.

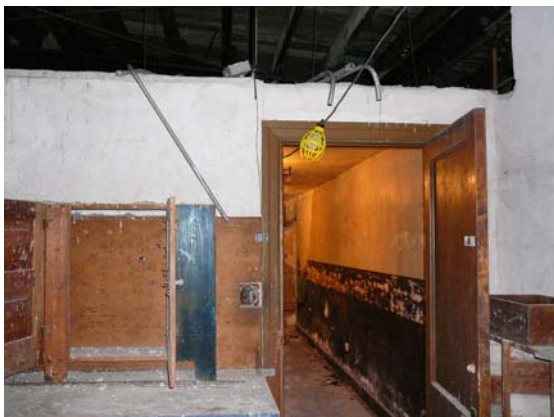
4. Storage room at east side of mezzanine

Storage room (image 4): The storage room is located at the furthest end of the main corridor. This area is open to the underside of the roof structure, providing access to a catwalk above the main auditorium. There is a large window on the east side just above the fresh air duct intake below. A closet takes up the remainder of the exterior facing wall.

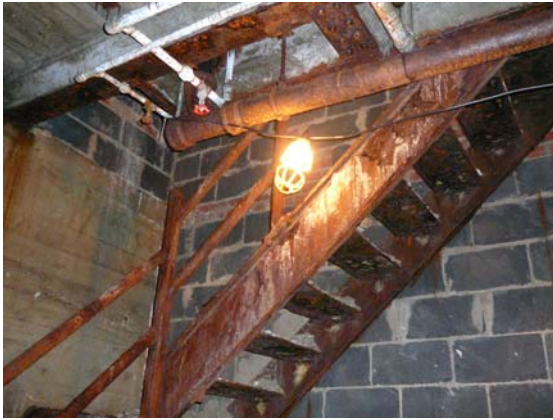
1. Metal stair from basement

The general conditions for the basement are to be considered poor. Metal stairs are rusted and in need of replacement. The mechanical systems are original to the building and are non-functional. Electrical equipment is missing and remaining equipment and wiring are in need of replacement. Structurally, the basement is in good condition with no visible signs of failure. All mechanical, plumbing and electrical systems are antiquated and should be abandoned. The original mechanical system with through-floor plenums is not code compliant, nor are the duct chases which supply air to the entire facility.

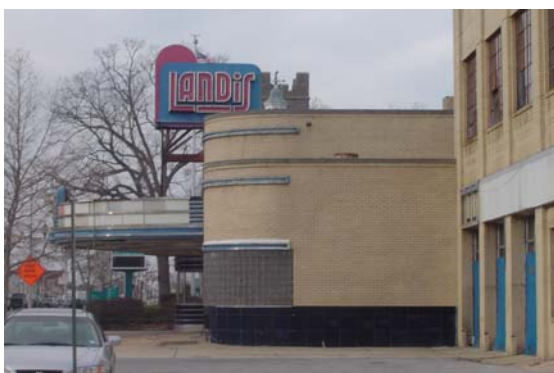
4. Side view of theatre showing curved walls and glass block

Overall the exterior of the facility is in good condition structural. The lack of control joints have caused cracking in the brick veneer in various locations. All metal accent trim at the front façade of the theatre is in poor condition. There is no evidence of neon lighting on the façade. The structural glass block are in fair condition with some damaged units. The pre-cast coping joints have failed. The canopy is structurally sound although much of the trim work need repair or replacing. The soffit below the canopy is failing. The marquee’s sheet metal is rusting and major portions are missing. The framework for the marquee is intact. The windows of the theatre are non-existent. Overhead doors at the Mori building are boarded up and non-functional. The smaller windows on the ground floor of the Mori are also boarded up. The upper windows are in various states of deterioration with rusted and missing metal frames and broken / missing glass panes.

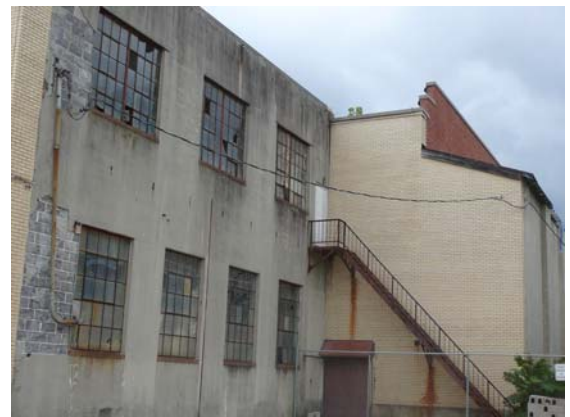
5. North façade of Mori building with exterior stairs

Stucco at the rear of the Mori is failing due to moisture penetration. The entire roof of both buildings need replacement. The roof structure of the Mori building requires total replacement. Portions of the roof structure of the theatre must be replaced.
