The Landis Theatre / Mori Brothers Building complex is located on the southwest corner of Landis and East Avenues. City of Vineland Tax Maps indicate the property as Lot 7 of Block 454. The physical address of the property is listed as 834—836 E. Landis Avenue.

Outer Lobby

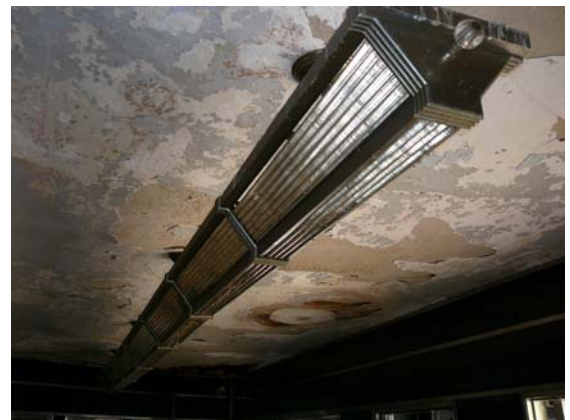
Custom hanging light fixture with glass rods

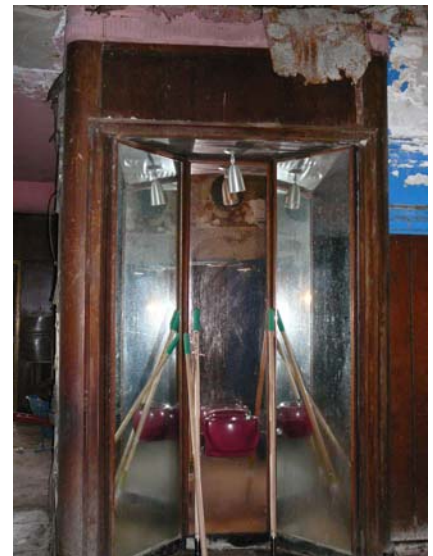
Drinking fountain alcove with movable mirrored sides

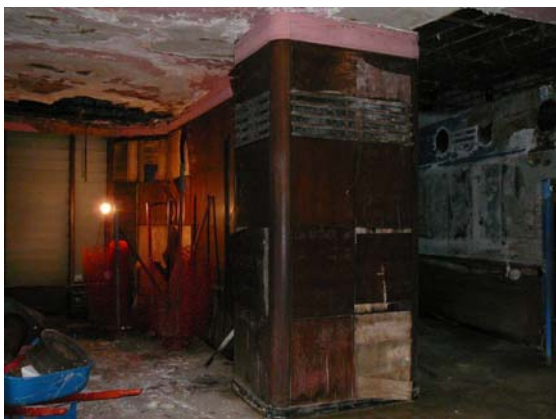
West side of outer foyer with glass louvered wall

An overall assessment of the foyers is very poor. All finishes have suffered extensive damage and considered unsalvageable in their current state. In addition, the existing construction will not meet current building standards and need to be modified.

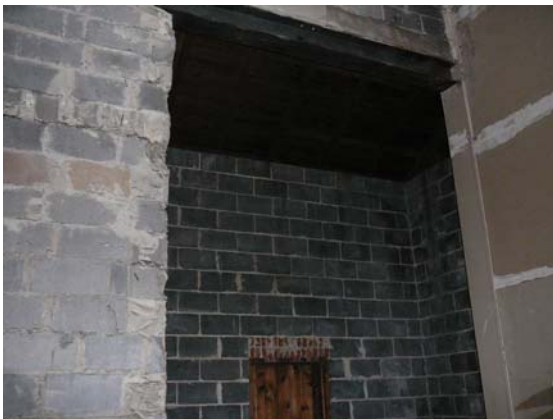
Stage annex , addition to main structure

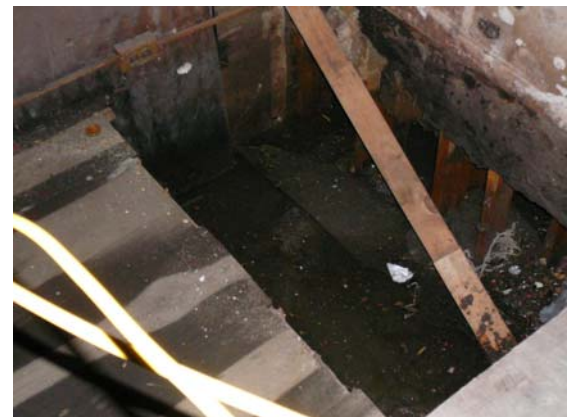
The steps leading to the stage directly from the auditorium are structurally unsound as are the platforms flanking them. The orchestra pit has been filled in with light framing. The pit is undersized for today's needs with room for approximately 4 individuals.

Orchestra pit with wood framed platform

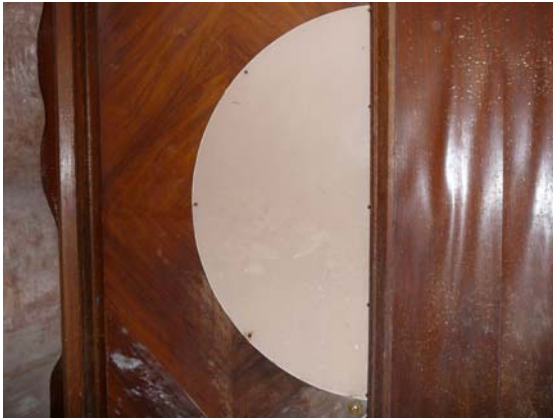
Wood veneer paneled door w/ half-circle laminate decoration

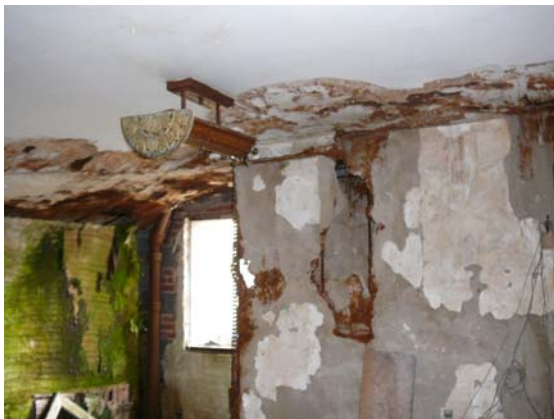
2. Theatre office

Office (image 2): The office is located immediately to the right as you enter the mezzanine level. A window to the exterior is provided on the south wall beyond the stair shaft.

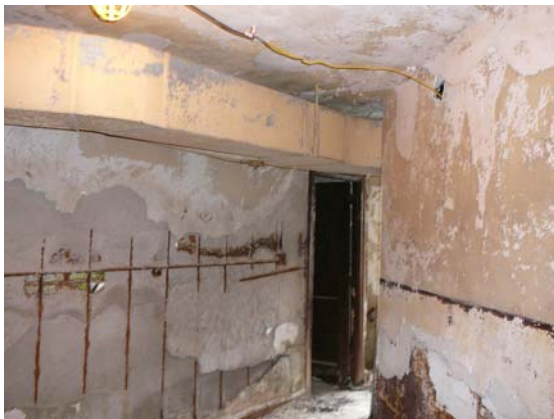
3. Corridor #1

Corridor #1 (image 3): The first corridor in the mezzanine provides access to the main corridor penetrating through a steel roof truss.

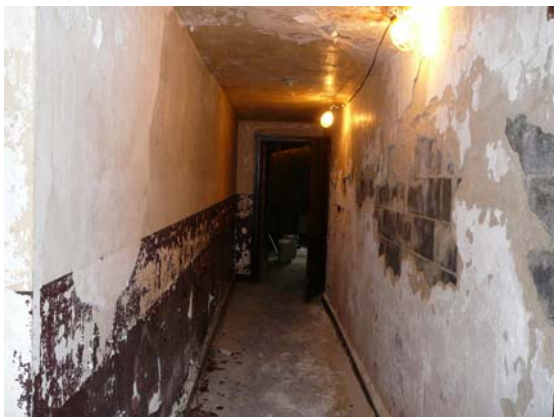
4. Corridor #2

Corridor #2 (image 4): The main corridor provides access to the remaining mezzanine spaces including the projection room.

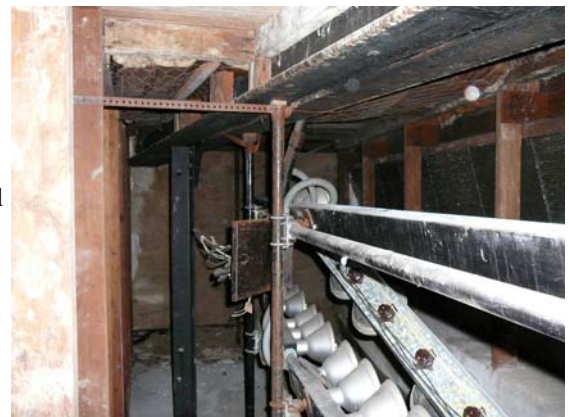
5. "Rainbow Light" bank at east side of mezzanine

Rainbow lights (image 5): The rainbow light banks were originally used to illuminate the main auditorium. There are located just beyond the north walls of the storage room and employee lounge in curved alcoves.
